Totley Bridleway repairs

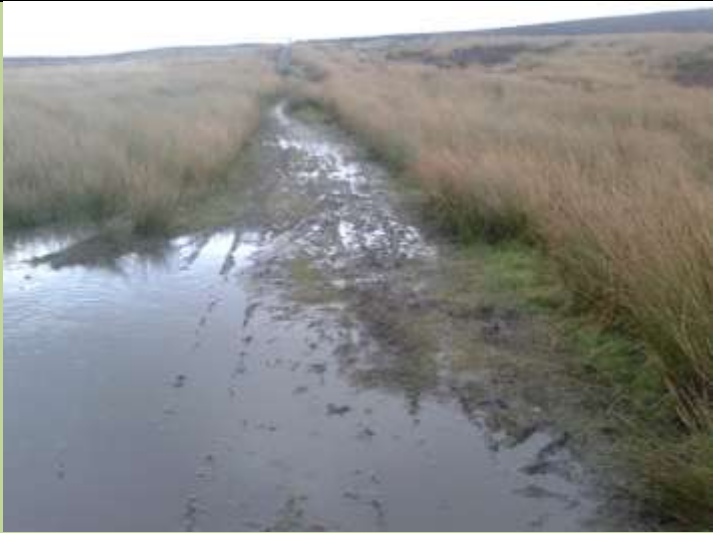
| Section No. (see figure 1) | Grid reference | Length of section (m) | Current condition | Desired outcome and action | Resources |
|---|---|---|---|---|---|
| 1 | 427360, 380190 to 427460, 380160 | 100m | | Surface of track free from mud and puddles | 40 tonnes of 40mm – 20mm gritstone/ 20mm – dust gritstone over section 1 and 2 |

The condition of the public bridleway on Totley Moor that joins Moss road to Stony Ridge road has deteriorated over the last few years. The table below shows the proposed works to repair the wet, muddy sections of the track. Over the worst section nearest the road (section 1), the plan is to have a 1m wide surface of stone that will grass over in time 40mm – 20mm gritstone topped with 20mm-dust gritstone will be used to surface the track. On section 2 stone will be used to fill ruts and puddles to maintain the grassy nature of the track.

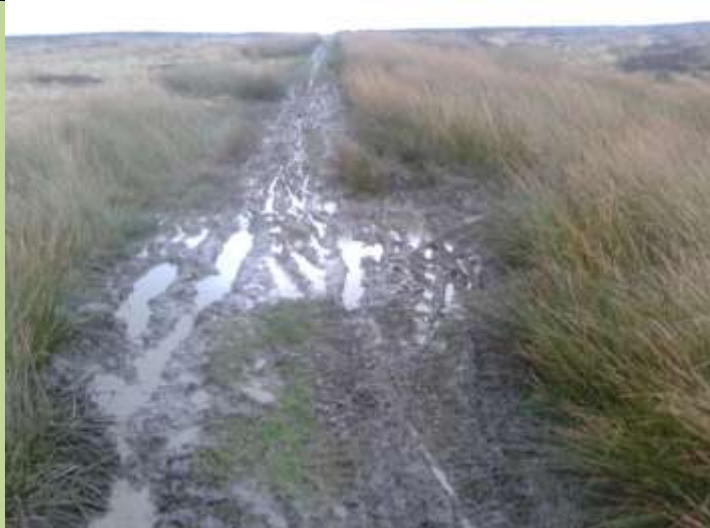
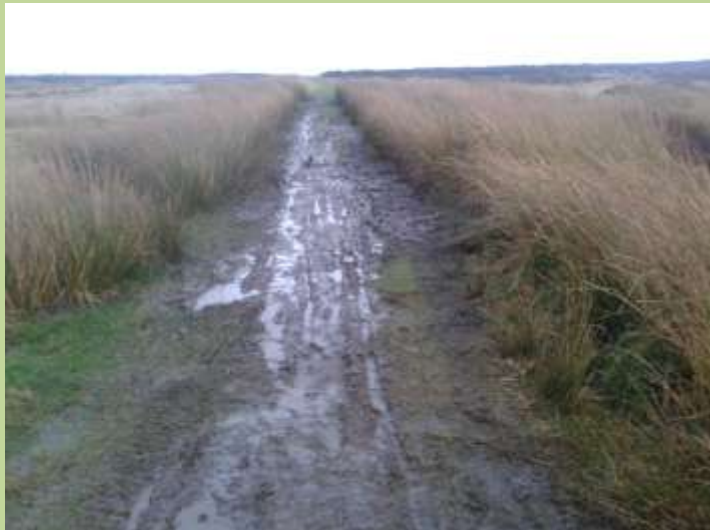
| 2 | 428139, 379397 to 428065, 379444 | 10m | | Surface of track free from mud and puddles | 40 tonnes of 40mm – 20mm gritstone/ 20mm – dust gritstone over section 1 and 2 |
